## Failure Analysis of a Water Filter Housing

*Dr. Duane Priddy, Plastic Failure Labs*

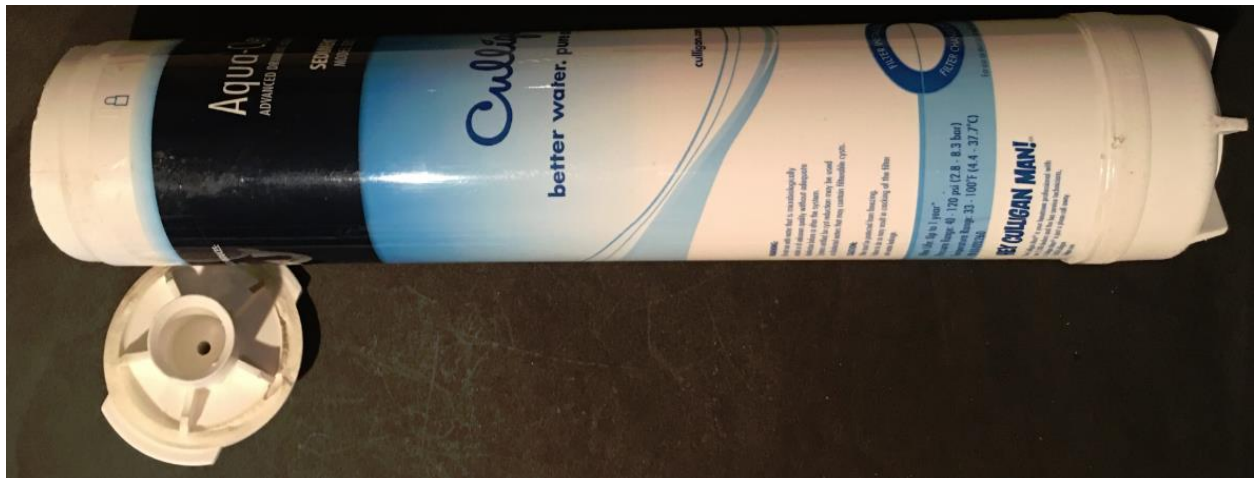
A photograph of the failed water filter is shown in (Figure 1). A molding void defect was visible in the fracture surface (Figure 2).

**Figure 1.** Water filter as received.

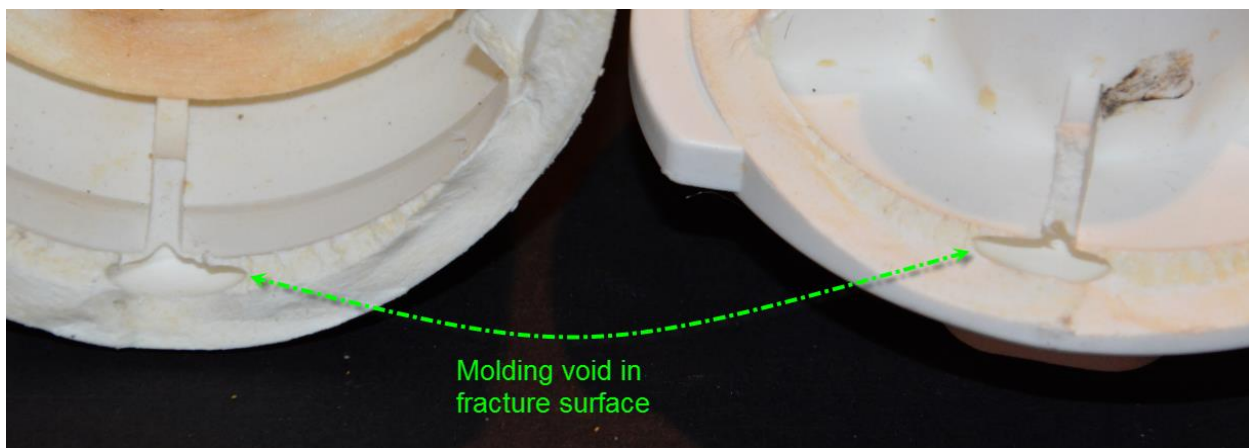
The root cause of the water filter housing failure was a molding defect. The molding defect was a large void which reduced the thickness of the material and initiated fracture.

**Figure 2.** A large molding void was visible in the fracture surface.
