Root Cause of Failure of a Chemical Transfer Hose

Dr. Duane Priddy, Plastic Failure Labs

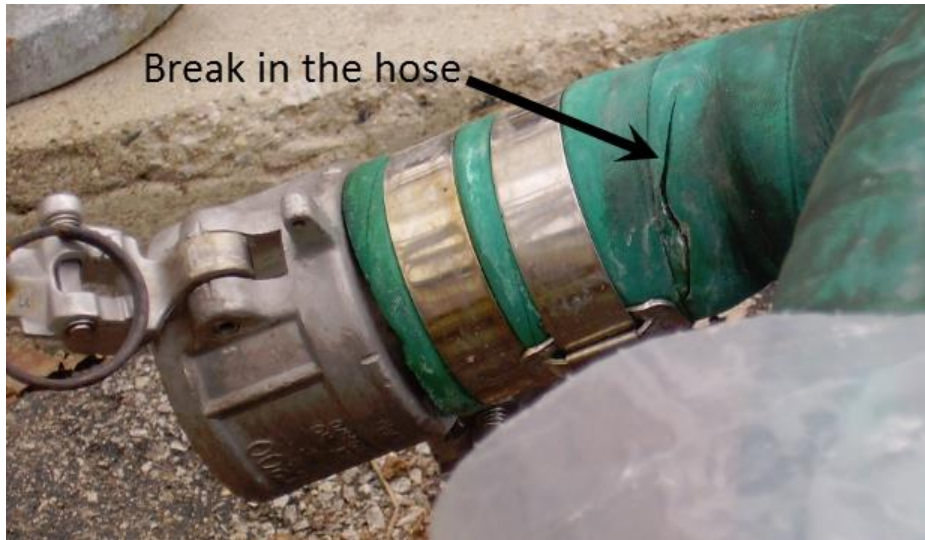
Figure 1. Photograph of the failed hose showing the location and appearance of the break.

The failed hose was forensically analyzed using optical microscopy, scanning electron microscopy (SEM), electron dispersive spectroscopy (EDS), Fourier Transform Infrared Spectroscopy (FTIR), and differential scanning calorimetry (DSC). These tests revealed that the UHMWPE inner layer failed in a ductile manner by fatigue and did not fail by chemical attack or by chemical degradation. Bending stresses on the hose were concentrated in an area close to the stainless steel coupling. Repetitive bending stresses at the same point in the hose over an extended period of time ultimately caused the hose material to locally fatigue.
